# Algae Control in Auckland Dam

## Drinking water reservoir, Watercare, New Zealand

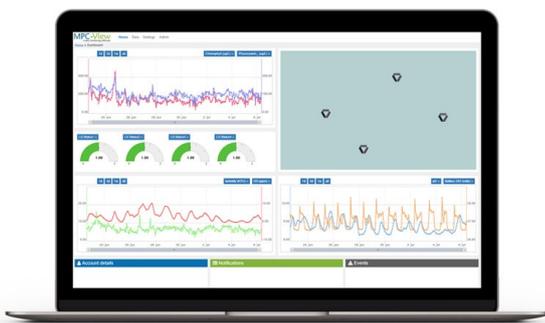
Figure 1: Continuous water quality monitoring combined with web-based software allows for an early warning of toxic algal blooms.

Since the installation in December 2016 the project appeared to be of great success. The blue-green algae count proved to be 90% lower during the summer compared to the previous year. The real-time water quality data predicts new algal blooms allowing them to be controlled before they become a problem.
